merit industries, inc.

FIELD BULLETIN

Date: 07-30-01

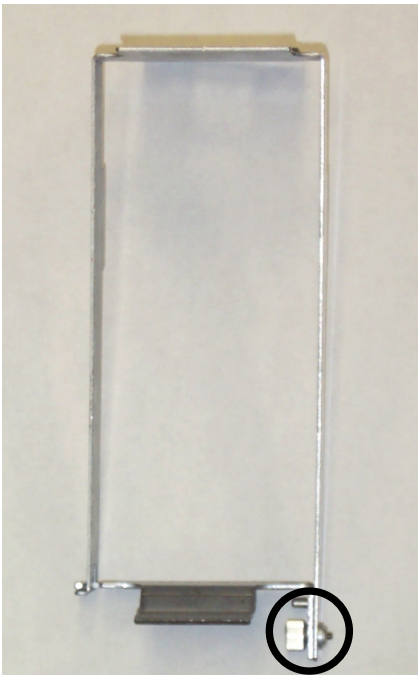
- Issue:** The thumbscrew on the bottom bill acceptor clamp could interfere with the wires of the bill acceptor.
- Games affected:** Elite MAXX™ with integrated bill acceptor model numbers: G20-106-304-02, -04, -06, -08, -10 and G20-106-307-02

FIGURE 1: LOCATION OF THUMBSCREW ON BILL ACCEPTOR CLAMP

- Symptoms:** The thumbscrew protrudes past the bracket.
- Cause:** The thumbscrew on the clamp is too long.
- Solution:** If you have an Elite MAXX™ with integrated bill acceptor, check the thumbscrew on the bottom bill acceptor clamp (see Figures 1 and 2). If the thumbscrew in your game protrudes past the captive nut on the bracket, contact Merit Industries Customer Service at 1-800-445-9353 or 215-639-4700 to receive a new clamp, which will be equipped with a shorter thumbscrew. Please have your game model number and serial number ready when you call. Be sure to also inspect the wires near the bill acceptor to ensure they have not been damaged. Contact Merit Industries if the wires are damaged.

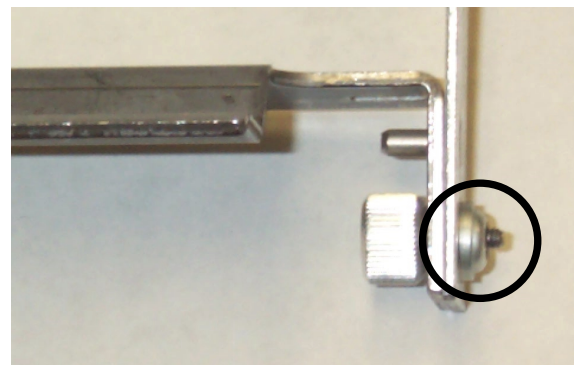
FIGURE 2: CLOSE-UP OF PROTRUDING THUMBSCREW
