# TECHNICAL SERVICE BULLETIN

6-2-95

merit industries, inc.

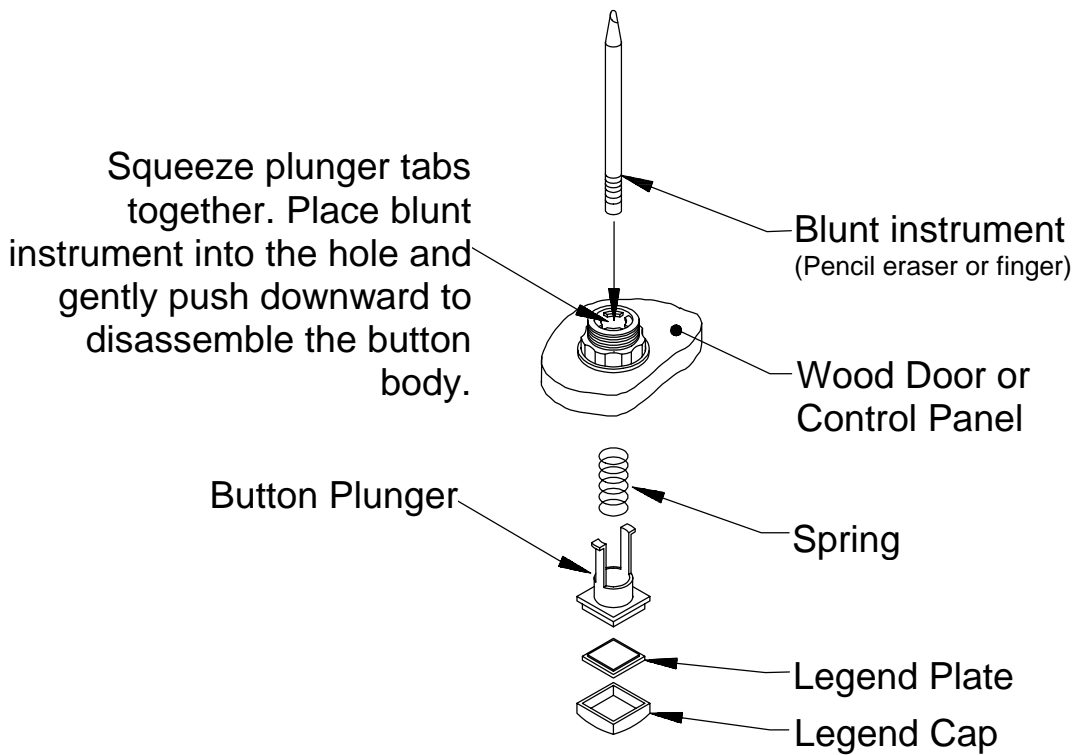
Figure 2 - Disassembled View of Button Body

- Problem:** Sticking buttons and/or intermittent button operation.
- Games affected:** Scorpion™ Stinger games and upright button games.
- Symptoms:** Buttons not working properly.
- Cause:** Button plungers molded from defective materials. The light bulb will melt the plunger under normal operating conditions.
- Solution:** Replace plungers. Replacement plungers are available, free of charge, from Merit Customer Service, at 1-800-445-9353, your local distributor or from the manufacturer, WICO Corporation, at 1-800-323-4258. Please be prepared to specify “Small Square” and/or “Rectangular” style button.

3. Remove the button plunger (from all effected buttons) by squeezing the two tabs together and gently pushing the plunger assembly out of the front of the control panel. See Figure 2 for description and location of the button plunger.

4. Remove the spring, legend plate and legend cap from the plunger.
5. Put the spring into the new plunger and attach the legend plate and legend cap to the new plunger.

6. Replace the plunger assemblies in their corresponding button body, making sure the legends are oriented properly.
7. Reattach the switch assemblies. Be sure that the switches are firmly snapped back into position.
