# TECHNICAL SERVICE BULLETIN

Date: 5-11-95

merit industries, inc.

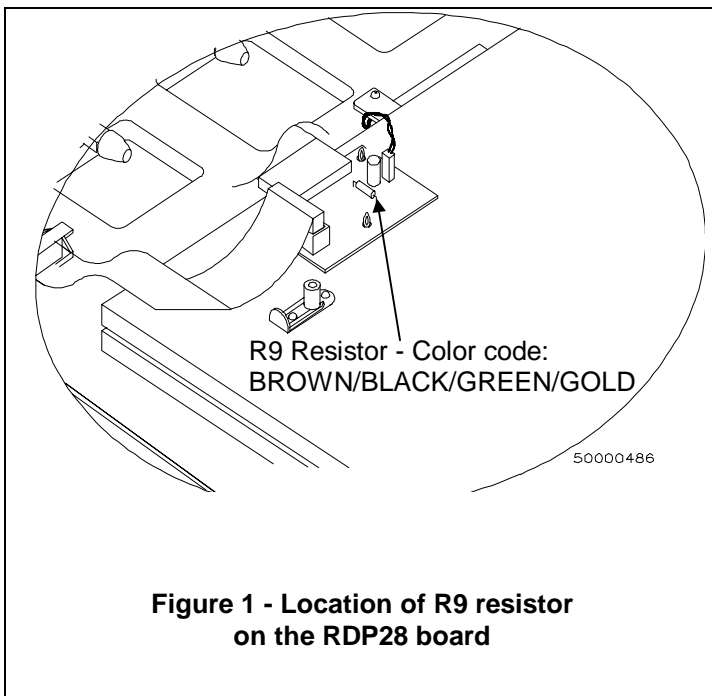
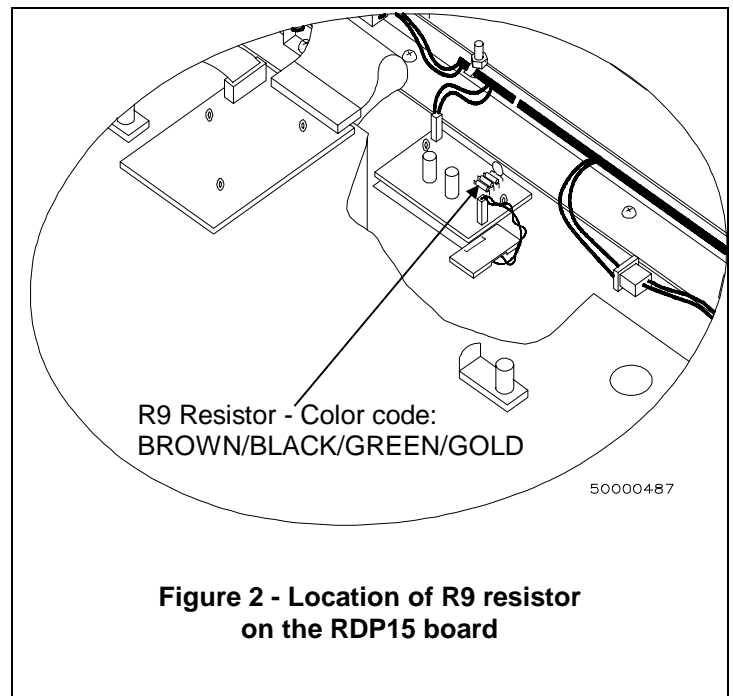
- Problem:** Darts being counted as “thrown” without a dart being thrown.
- Games affected:** All Scorpion™ Stinger games.
- Symptoms:** Darts are taken away; a player gets less than 3 darts per turn.
- Cause:** The amplifier gain is too high, causing the microphone to be too sensitive.
- Solution:** Reduce the gain on the microphone board by replacing the 1 megohm resistor (color code: brown/black/green/gold), located at R9 on the microphone board, with a 470 kilohm resistor (color code: yellow/violet/yellow/gold).

The microphone board is located in the target section, mounted to the matrix switch and wood assembly. The location of the R9 resistor, for each board, is shown below in Figures 1 and 2.
