TECHNICAL SERVICE BULLETIN

Date: 5/23/96

merit industries, inc.

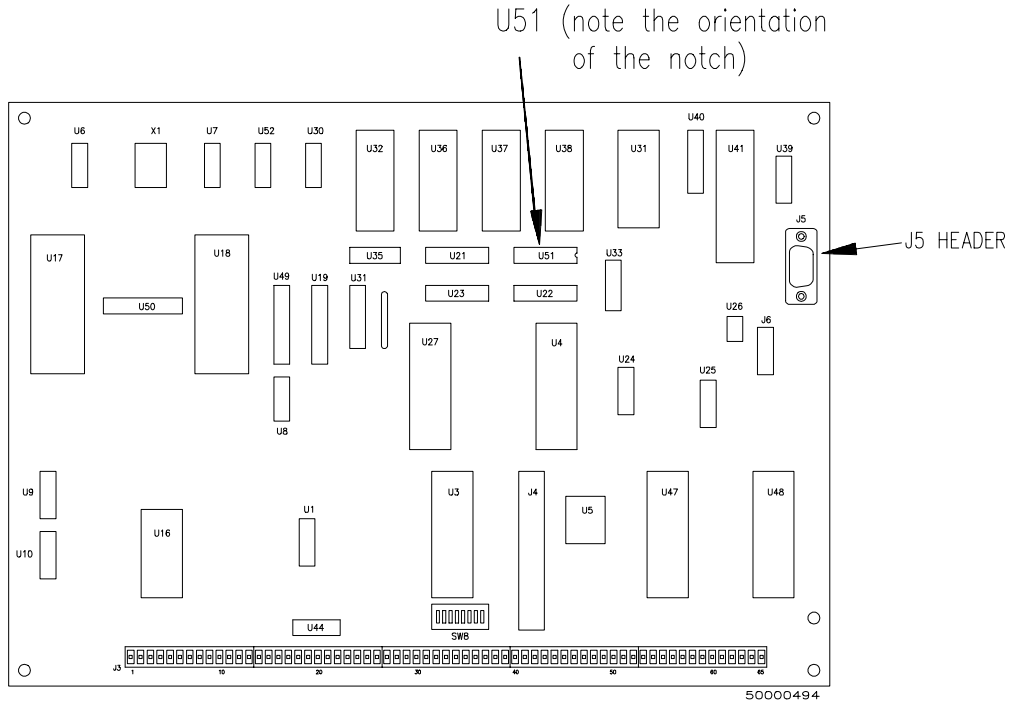
FIGURE 1 - CRT-260 CPU BOARD

- Problem:** Tournament Megatouch games' system date resetting to February 1995.
- Games affected:** A limited number of factory-made Megatouch Tournament games, and games that were field-upgraded to Tournament Megatouch, that use SC3981 at U51.
- Symptoms:** System date resetting to February 1995.
- Cause:** PAL programming may cause NV RAM error.
- Solution:** Replace U51 PAL SC3981 with SC3981-0A.

1. Turn off and unplug your game.
2. Open the CPU section door to access the CRT-260 board.
3. Using Figures 1 and 2, locate U51 on the CRT-260.
4. If your game comes equipped with the CRT-266/TTL touchscreen controller assembly, you will need to remove it to access U51 (U51 is located beneath this assembly).
5. Using a small screwdriver, gently pry the existing PAL from its socket.
6. Install the new PAL, SC3981-0A, at U51.
7. Reinstall the CRT-266/TTL assembly if you removed it.
