# TECHNICAL SERVICE BULLETIN

6-2-95

merit industries, inc.

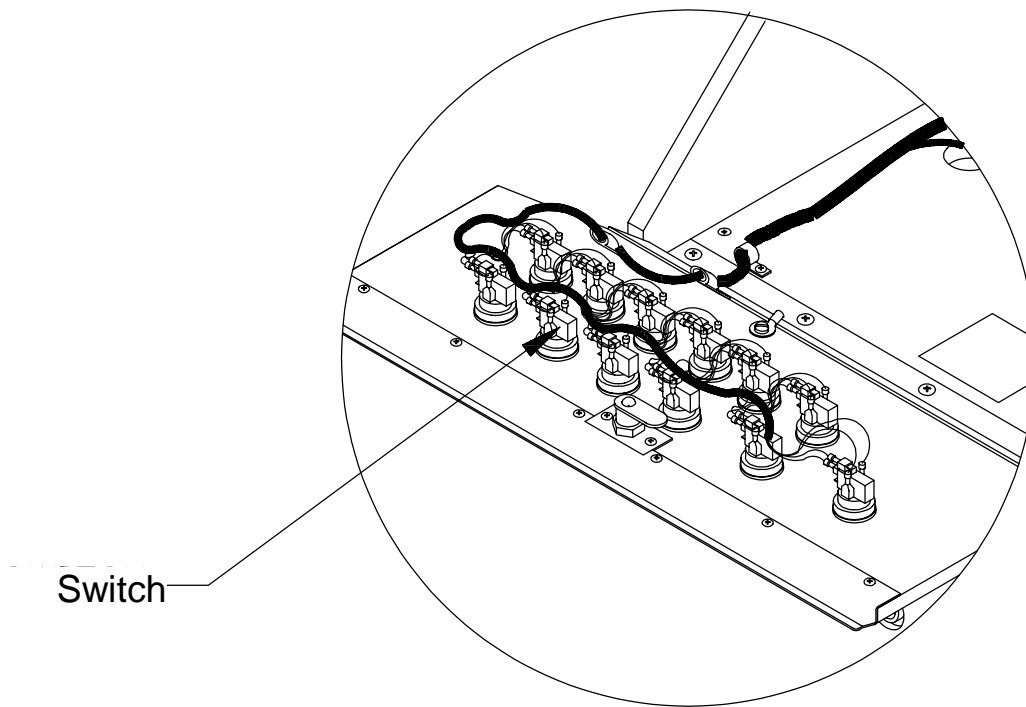
Figure 1 - Switch Location

- Problem:** Sticking buttons and/or intermittent button operation.
- Games affected:** Scorpion™ Stinger games and upright button games.
- Symptoms:** Buttons not working properly.
- Cause:** Button plungers molded from defective materials. The light bulb will melt the plunger under normal operating conditions.
- Solution:** Replace plungers. Replacement plungers are available, free of charge, from Merit Customer Service, at 1-800-445-9353, your local distributor or from the manufacturer, WICO Corporation, at 1-800-323-4258. Please be prepared to specify "Small Square" and/or "Rectangular" style button.

1. Open the control panel door to gain access to the rear of the button assemblies.
2. To replace the plunger, you must first remove the switch assembly from the rear of all effected buttons. To do this, gently rock the switch back and forth while pulling on it. For switch location see Figure 1.
