TECHNICAL SERVICE BULLETIN

Date: 06/28/95

merit industries, inc.

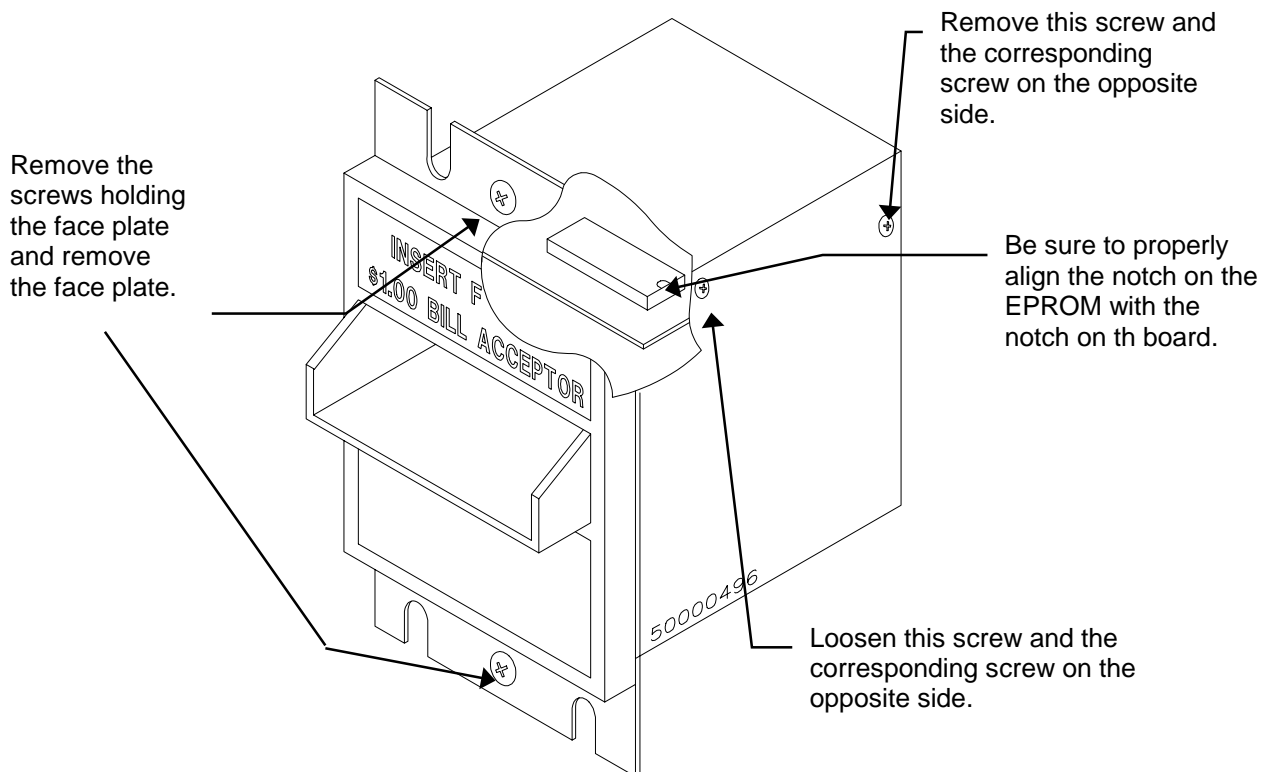
Figure 1 - Location of EPROM in JCM Black Stallion Bill Acceptor

- Problem:** JCM Black Stallion bill acceptor not accepting bills.
- Games affected:** All games with JCM Black Stallion bill acceptors.
- Symptoms:** Not taking bills, lights flashing.
- Cause:** Bad program EPROM.
- Solution:** Update EPROM in Black Stallion bill acceptor. Available from JCM at 1-800-683-7248, your local distributor or Merit Customer Service at 1-800-445-9353.

1. Remove the face plate screws and the face plate
2. Remove the screws holding the lid and remove the lid.
3. Remove the existing EPROM.
1. Install the new EPROM being careful to align the notch on the EPROM with the notch on the board.
